CONTAMINATION CONTROL IN HYBRID MICROELECTRONIC MODULES

IDENTIFICATION OF CRITICAL PROCESS AND CONTAMINANTS
FINAL REPORT – PART I

Contract No. NAS 8-30876

AEROSPACE GROUPS
Hughes Aircraft Company, Culver City, California 90230

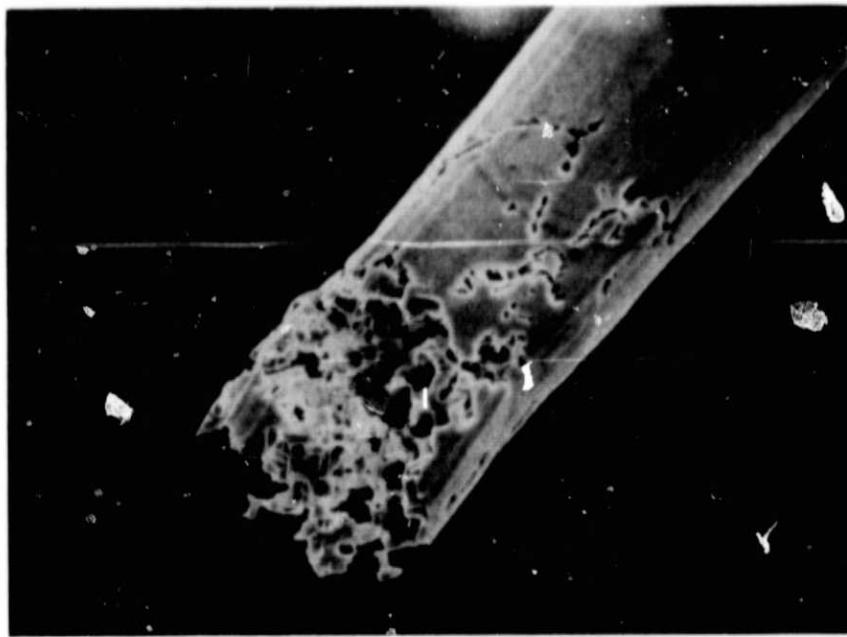
cleaning is required, the potential exists for contamination from residual cleaning solvents. Figure 2 shows the effect of such contamination (in this case, chlorine-water) on a 0.0025 cm (0.001-inch) aluminum wire. This type of contamination can be avoided by the use of degreaser-type final rinses.

Figure 2. Scanning electron microscope (SEM) photo showing corrosion of aluminum bonding wire caused by chlorine-water contamination. (1400x.)

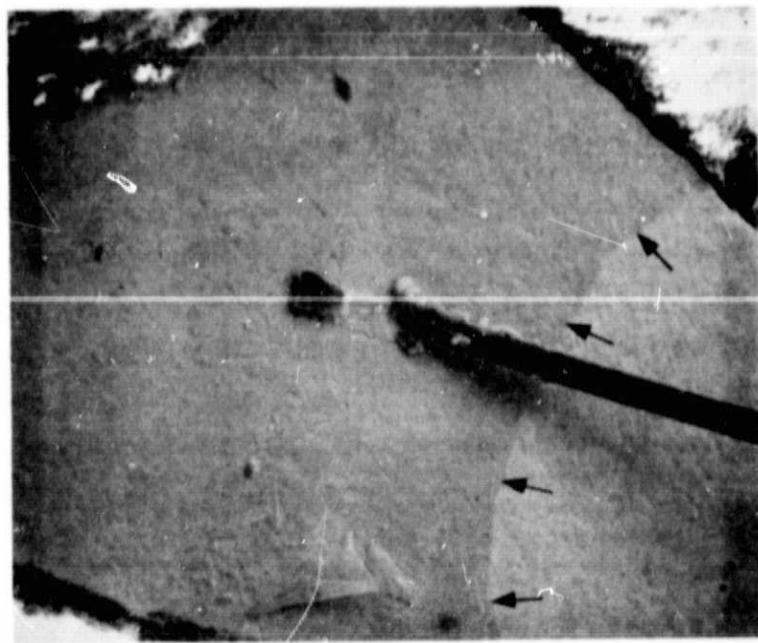
Figure 3. SEM photo showing degradation of aluminum wire bond due to residual contaminant (180X). (Edge of the stain shown by arrow)

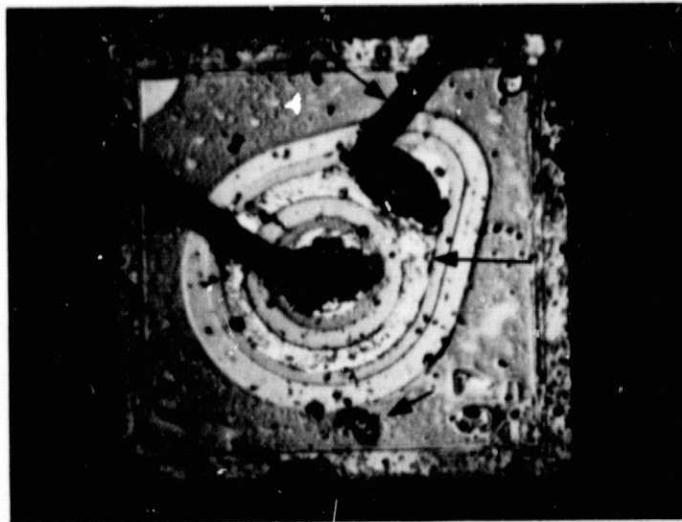
Figure 4. Transistor chip showing unknown surface contamination attributed to a poor solvent rinse. (120X)

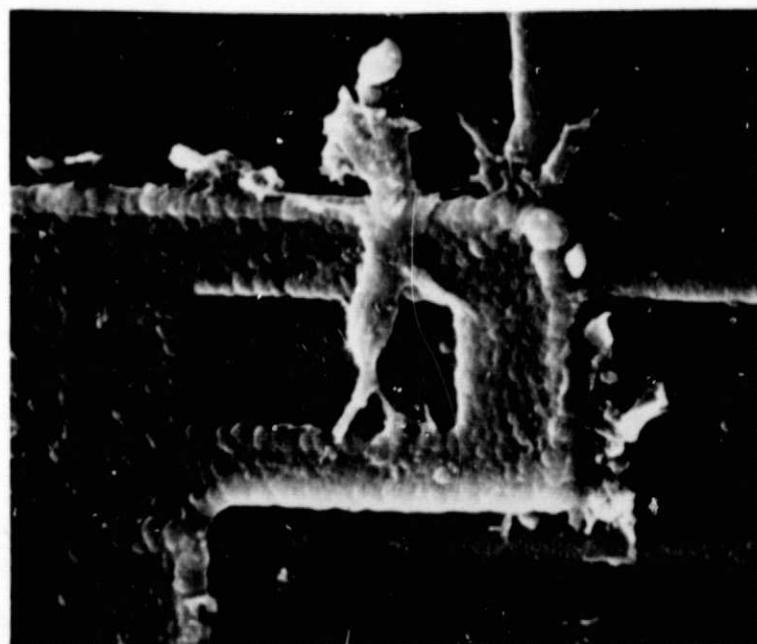
hybrid assembly area, is not unlikely. An example of such contamination is seen in Figure 5. Use of contaminated chips is probably best avoided by visual inspection and rejection before attachment. The cleaning of semiconductors in chip form is considered difficult and the added risk of damage to the chips makes this possibility less attractive as an in-process control step.

Figure 5. SEM view of contamination of semiconductor chip surface (1800X).

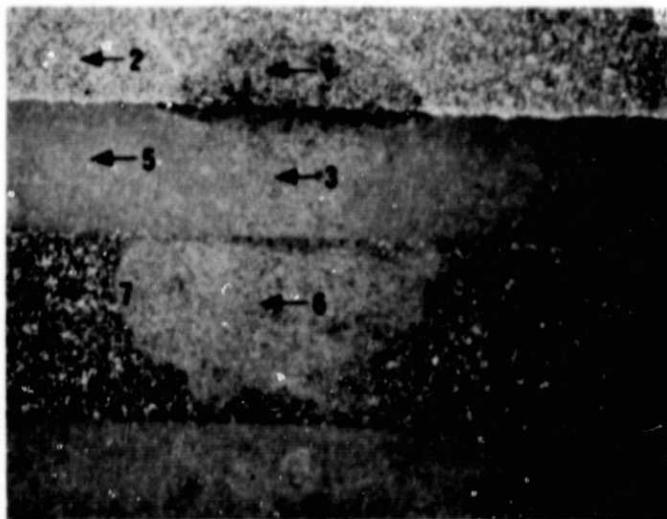
Figure 6. Contaminant residue and damage to nichrome resistor by electrochemical action (176X).

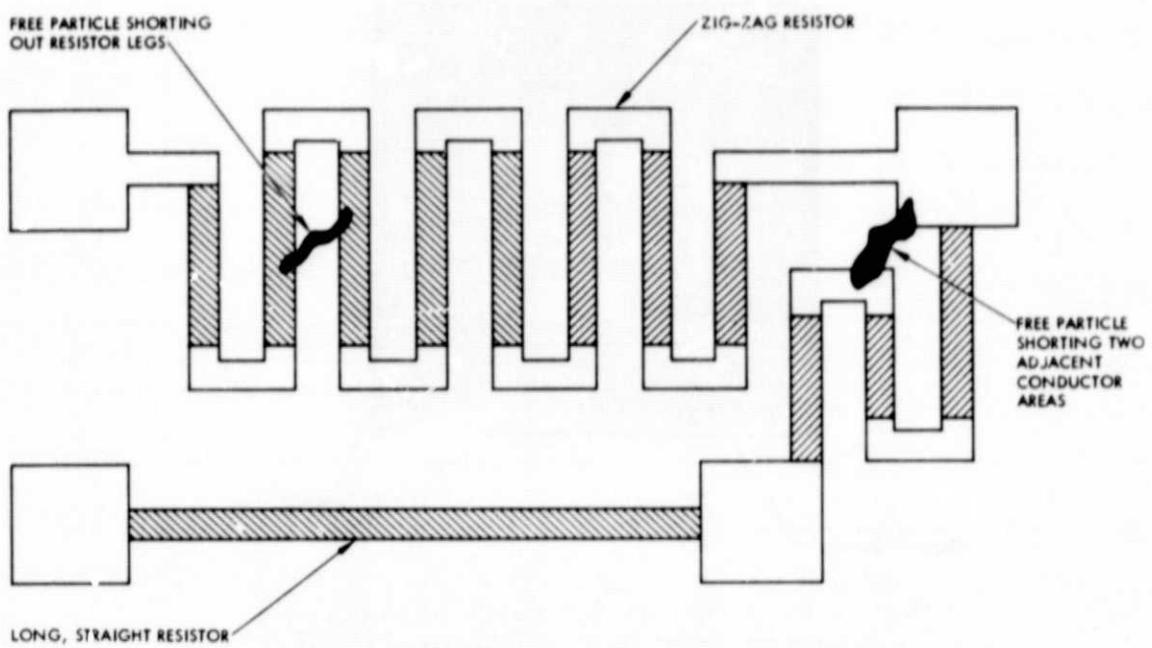
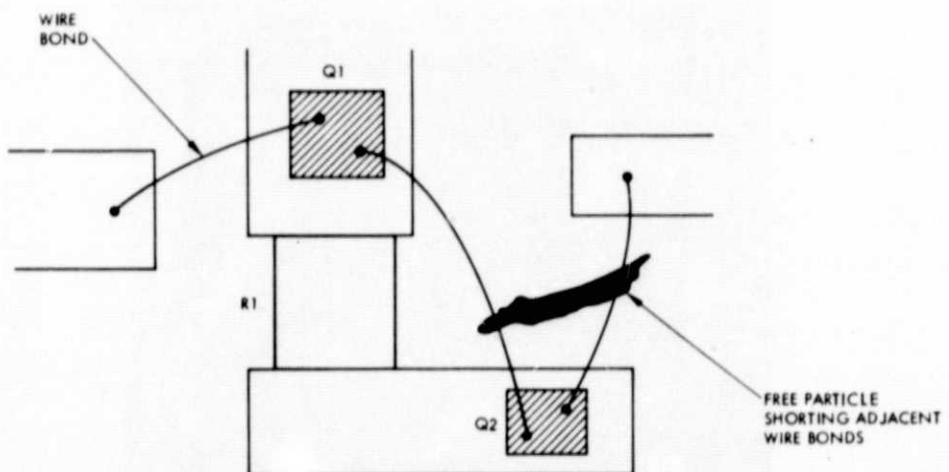
The sketches in Figure 7 and the photographs of hybrids in Figures 8, 9, 10, and 11 illustrate the loose particle danger. Not all particles such as these are conductive and not all particles are dangerous. However, the hazard is always present, especially with conductive particles.

Figure 7. Sketches illustrating how free conductive particles can short circuit resistor/conductor paths (top sketch) and wire bonds (bottom sketch).

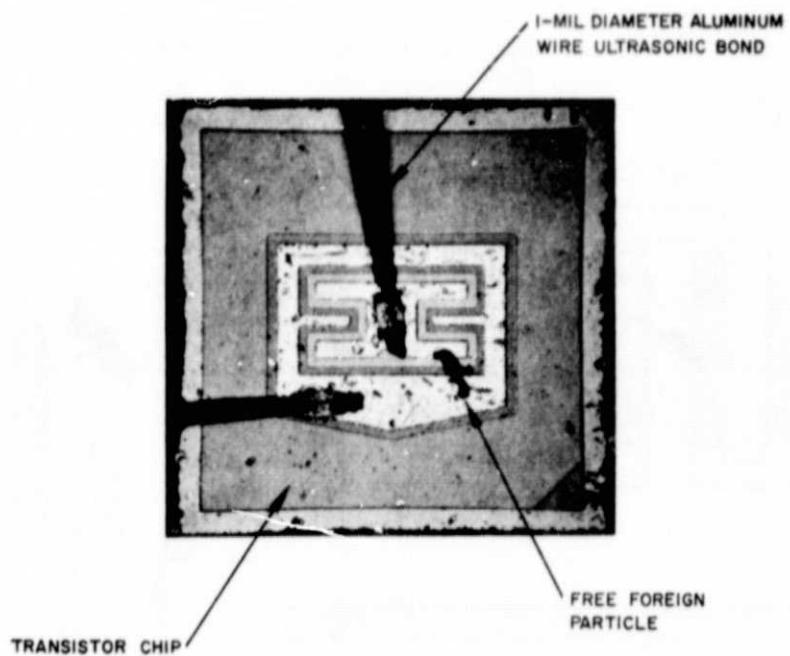
Figure 8. Free foreign particle that could cause a transistor chip failure (110X).

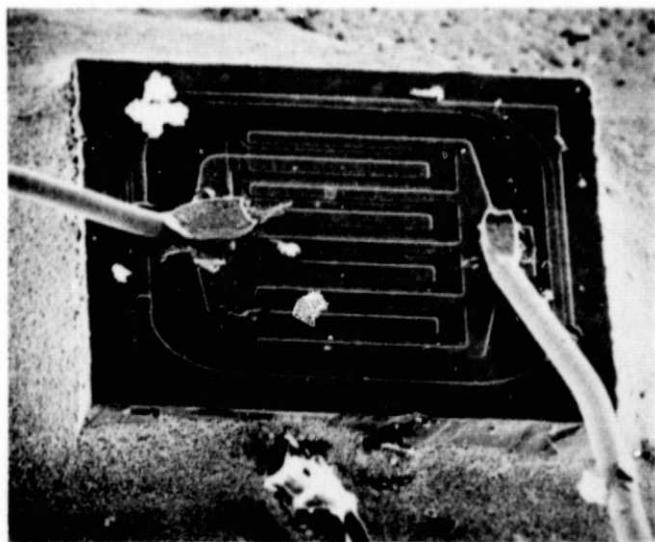
Figure 9. SEM photo at 180X showing unidentified particles on the surface of a transistor chip and an ultrasonic wire bond posing a potential short.

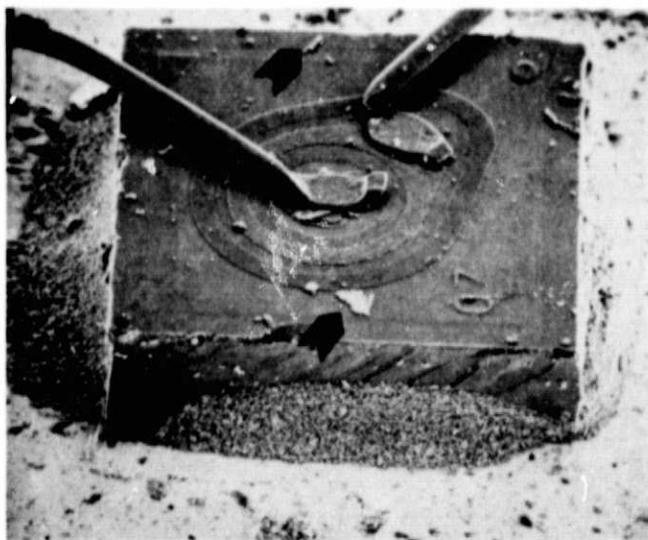
Figure 10. SEM photo at 180X showing unidentified particulate contaminants on a transistor chip and a wire bond with partially severed heel.

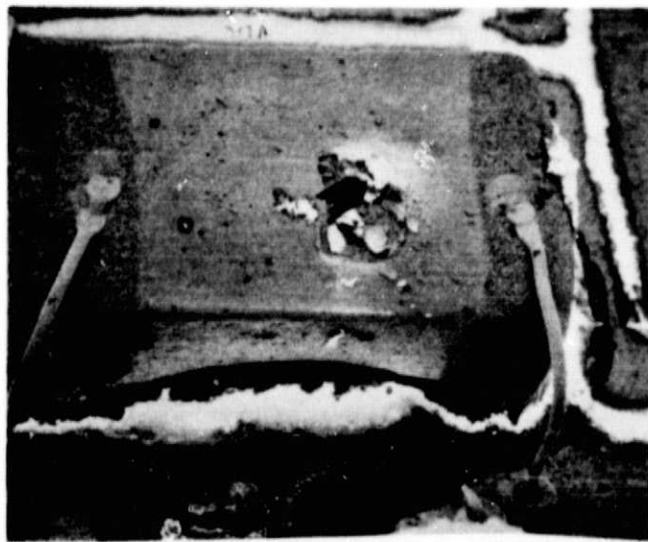
Figure 11. SEM photo at 47X showing a damaged capacitor chip. The particles resulting from the damage could easily become free agents and cause subsequent failure on another part of the hybrid circuit.
